Reading, Writing, And Rooftop Coating: Recoating A Louisiana Elementary School

BY JENNIFER FRAKES
PHOTOS COURTESY OF ATD

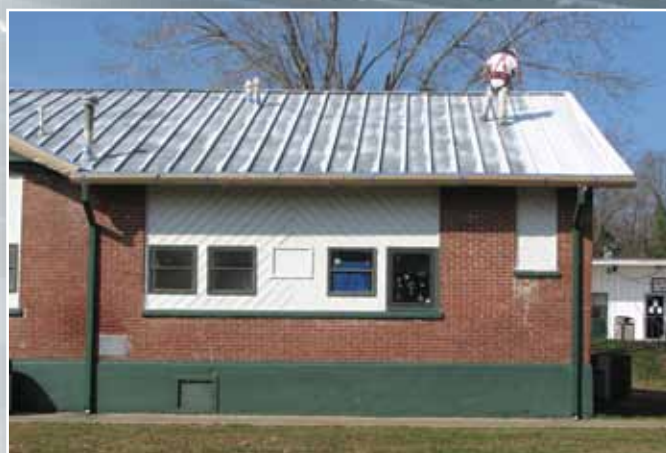
ABOVE ▲ In all, the ATD crew applied 60 gallons (227.13L) of PPG Coraflon ADS, a 2-component fluoropolymer coating, on top of the Coraflon primer. Using the same Graco equipment, the Coraflon ADS topcoat was spray-applied in two coats to achieve a total thickness of 5.5 to 6.0 mils (0.14mm to 0.15mm) DFT.

For this project, the two-man ATD crew applied 60 gallons (227.13L) of PPG Corafon ADS, a two-component fluoropolymer coating, to the substrate. Prior to installing the topcoat, the crew applied two coats of PPG Corafon 553/554 epoxy primer, which is recommended by PPG for use as the intermediate coat on steel and aluminum substrates. In total, 100 gallons (378.54L) of the primer was applied to the roof surface. Each coat of primer was applied at a thickness of 2.0 to 2.25 mils (0.051mm to 0.057mm) DFT, and the topcoat was applied in two

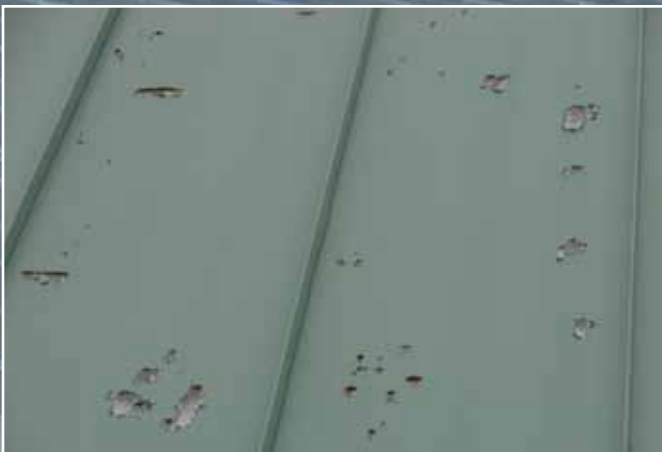
ABOVE ▲ The 25,000 sq. ft. (2,322.58m²) roof was experiencing spot corrosion — undercutting the film and exposing red rust and bare galvanized metal. “The elementary school is in Bourg, Louisiana which is in very close proximity to the Gulf of Mexico, so the humidity is very high which amplifies the levels of soluble salts on the surface of the roof. This causes an acceleration of the corrosion, further deteriorating the exposed zinc layer,” Ruff explains.

And these are exactly the conditions to which the 25,000 square foot (2,322.58m²) roof on the Bourg school is exposed. According to Ruff, the roof was experiencing spot corrosion, which was undercutting the film and exposing red rust and, in some places, bare galvanized metal. “The elementary school is in Bourg, Louisiana which is in very close proximity to the Gulf of Mexico, so the humidity is very high which amplifies the levels of soluble salts on the surface of the roof. This causes an acceleration of the corrosion, further deteriorating the exposed zinc layer,” says Ruff.

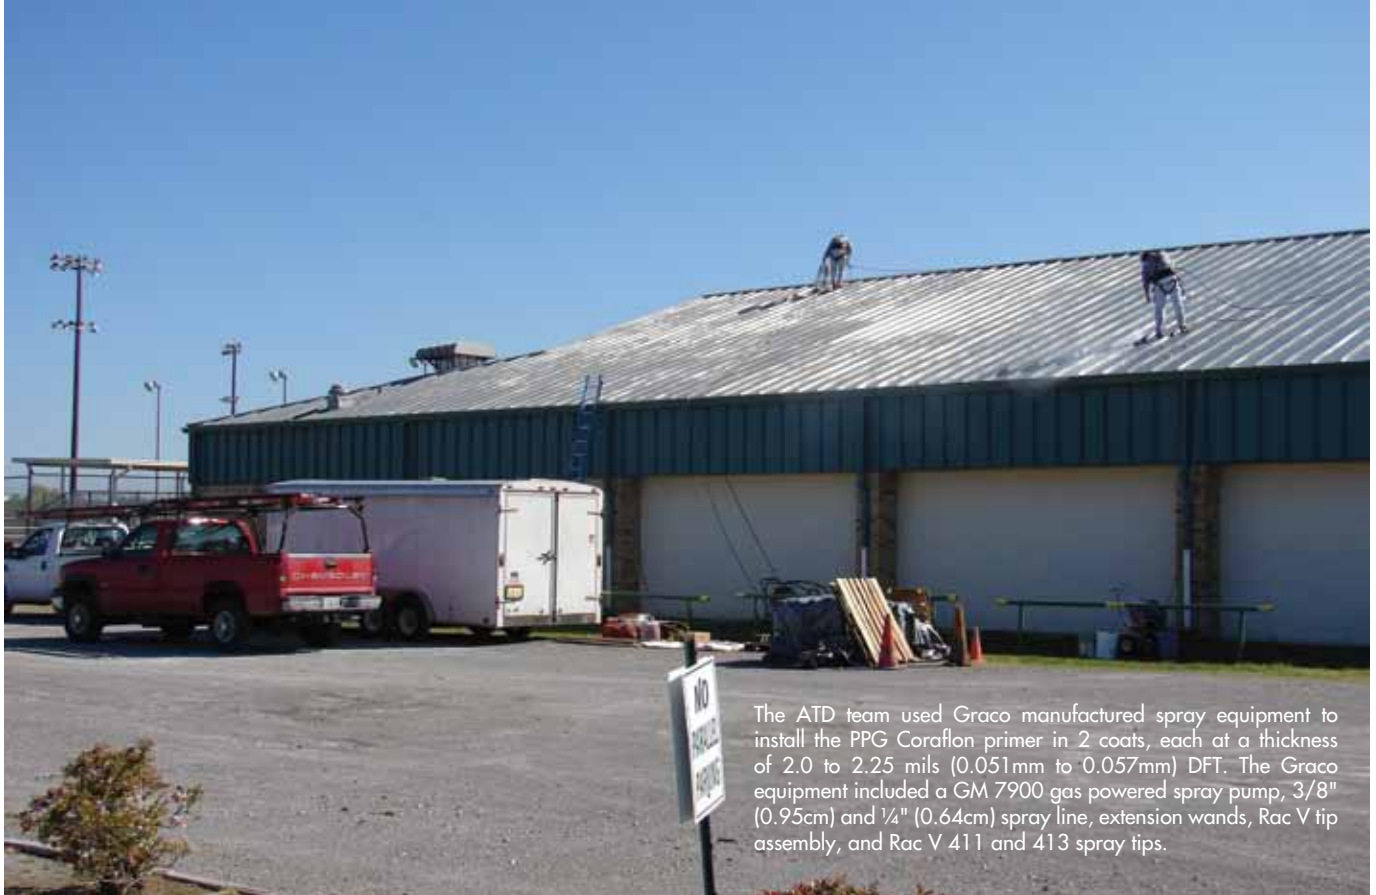
The ATD team used Graco manufactured spray equipment to install the PPG Corafon primer in 2 coats, each at a thickness of 2.0 to 2.25 mils (0.051mm to 0.057mm) DFT. The Graco equipment included a GM 7900 gas powered spray pump, 3/8" (0.95cm) and 1/4" (0.64cm) spray line, extension wands, Rac V tip assembly, and Rac V 411 and 413 spray tips.

The ATD team used Graco manufactured spray equipment to install the coating on the job. Their equipment included a GM 7900 gas powered spray pump, 3/8-inch (0.95cm) and ¼-inch (0.64cm) spray line, extension wands, Rac V tip assembly, and Rac V 411 and 413 spray tips.

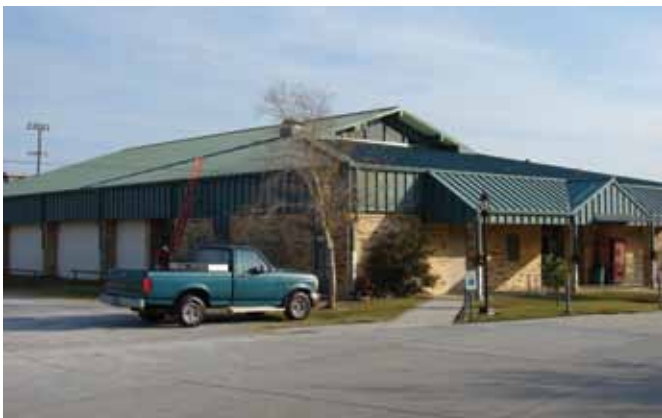
LEFT ◀ The specs required the ATD crew to completely remove the factory-applied coating system from the school’s metal roof, etch the substrate to an average 1-mil (0.03mm) profile prior to cleaning, spray-apply 2 coats of 2.0 to 2.25 mils (0.0508mm to 0.0572mm) each of PPG 553/554 Epoxy Primer, and spray-apply an additional 2 coats of Corafon ADS for an average 1.5 mils (0.0381mm) DFT topcoat.

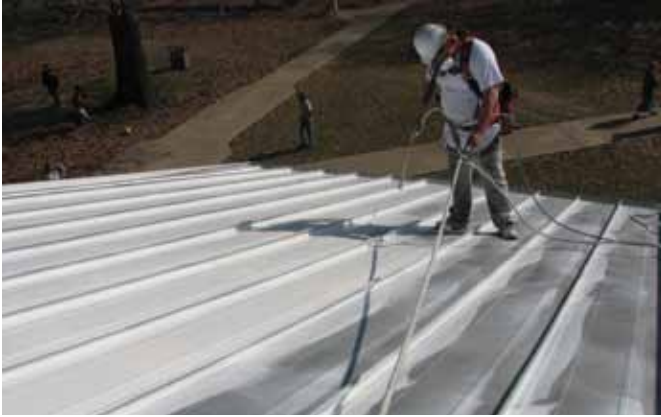
ABOVE ▲ The Coraflon product has a 16.2 to 1 ratio, making it more complicated to apply than coatings that have a 1:1, 2:1, or even 3:1 ratio. “There is a definite learning curve when applying the product,” relates Ruff.

The Coraflon product has a 16.2 to 1 ratio, making it more complicated to apply than coatings that have a 1 to 1, 2 to 1, or even 3 to 1 ratio. “There is a definite learning curve when applying the product,” relates Ruff.

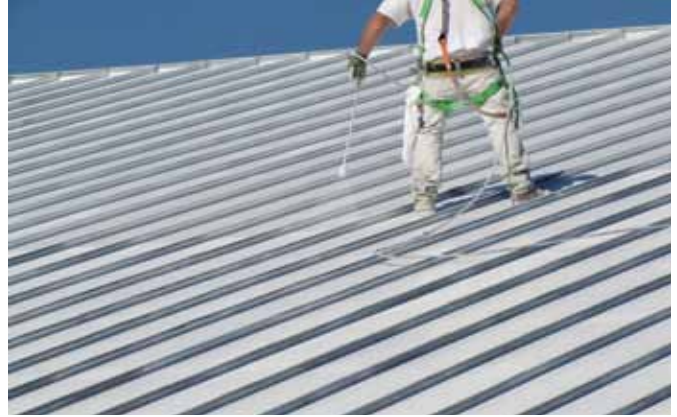
ABOVE ▲ In addition to the safety of the students and neighbors below, the personal safety of the crew was important. Ruff and his team wore Spider construction harnesses with D-ring positioning using rope grabs and 5/8" (1.59cm) rope, to remain safe and comfortable when working on the steeply pitched roof. They also wore respirators and fresh air blast helmets with peel-away shields.

During each step of the project, from surface prep to the final application of the topcoat, the personal safety of the crewmembers was a top priority. Spider construction harnesses with D-ring positioning were used, along with rope grabs and 5/8-inch (1.59cm) rope, to keep personnel safe and comfortable during work periods. The crew wore respirators and fresh air blast helmets with peel-away shields.

“It was extremely important that the crew be safe and comfortable because, with the 7:12 pitch of the roof, hand rails couldn’t be installed. The crew had to rappel, which is very physically demanding,” says Ruff.
